# “Beating” Effect Caused by Two Closely Spaced Mechanical Frequencies Observed on Two-Shaft, Gas Turbine Drive

# Two Shaft Gas Turbine Configuration

The subject gas turbine drive is a Solar Centaur 47 Gas Turbine located at a gas processing facility in South Texas.

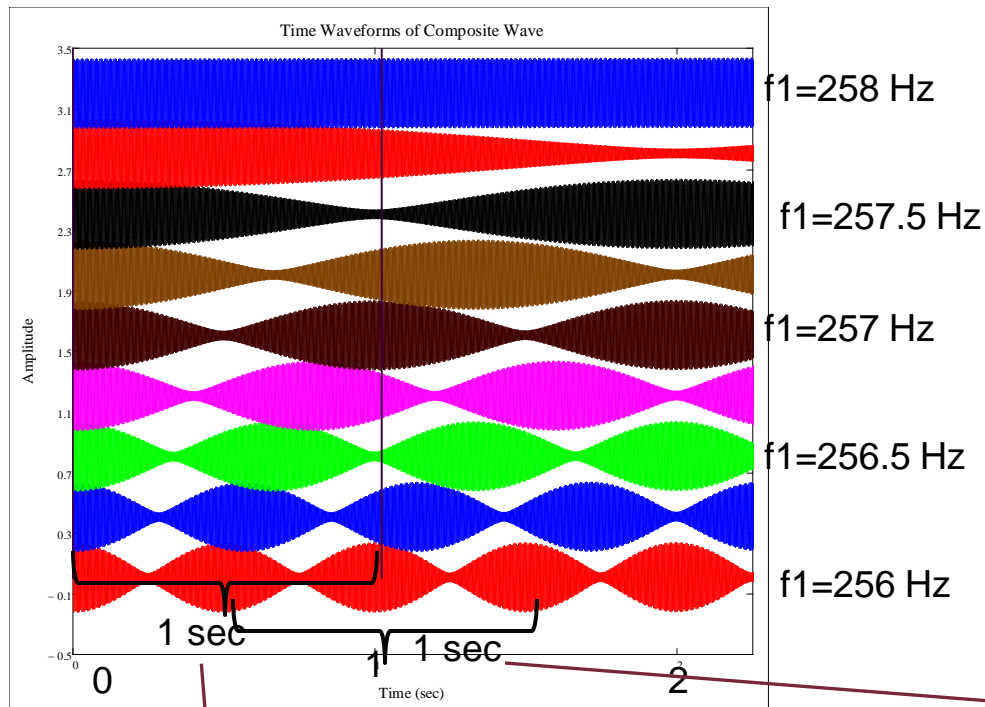
# Resulting Graphs: Set 1

The time waveforms on the left are the composite wave as the first waves' frequency changes.

The four figures on the bottom are the spectrums if the start time of the 1 sec. sampling shifts to the right. This is essentially a phase change. No 1X pick up on PT-GP system.

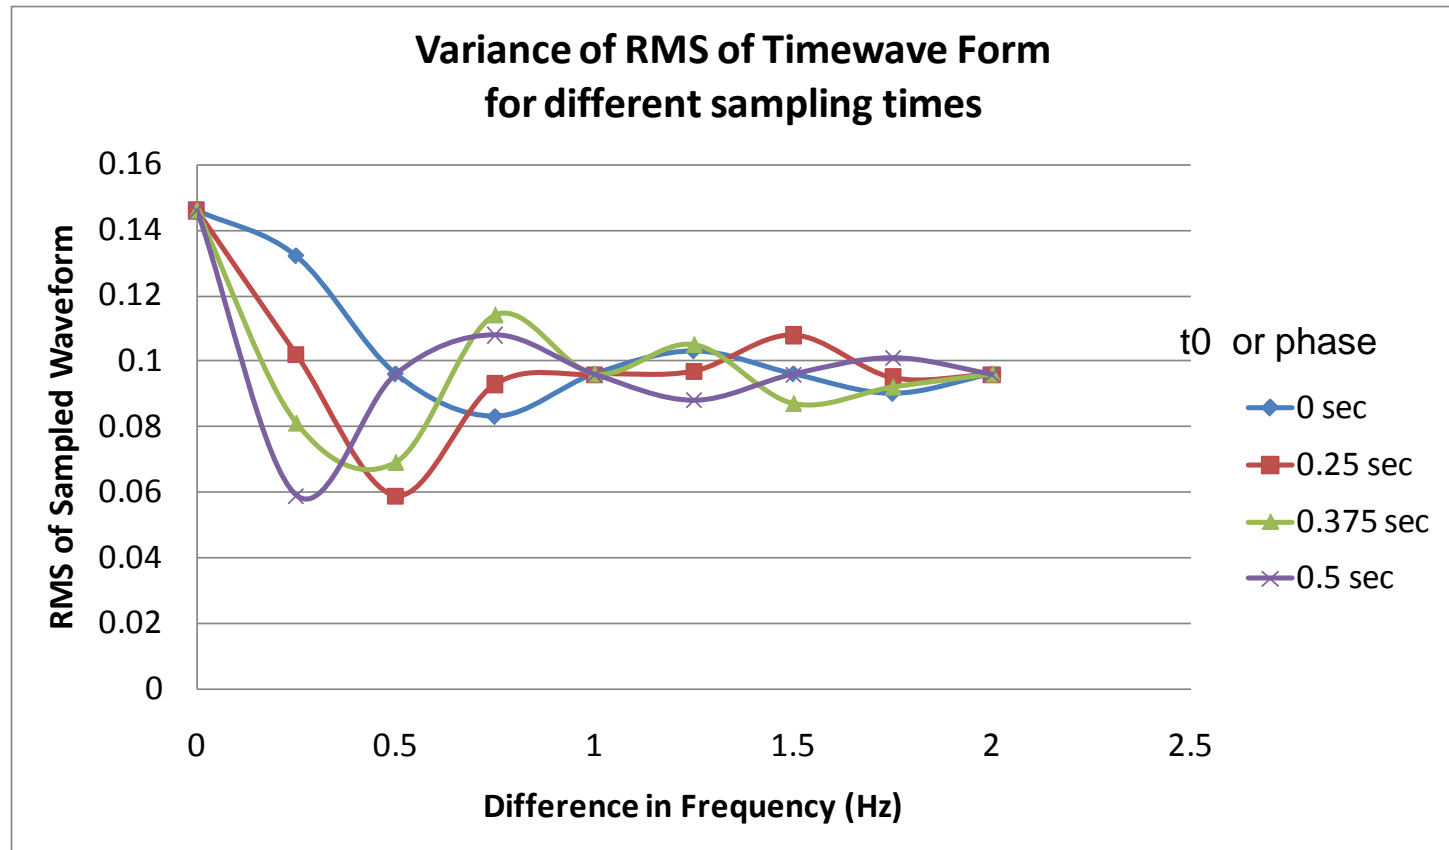
## Resulting RMS Graphs: Set 2

If the rms of a 1 second time waveform sample is examined, and the time as to when the sample is measured is changed, there can arise a wide swing of the rms value when the difference between the two signals is less than 1 Hz.

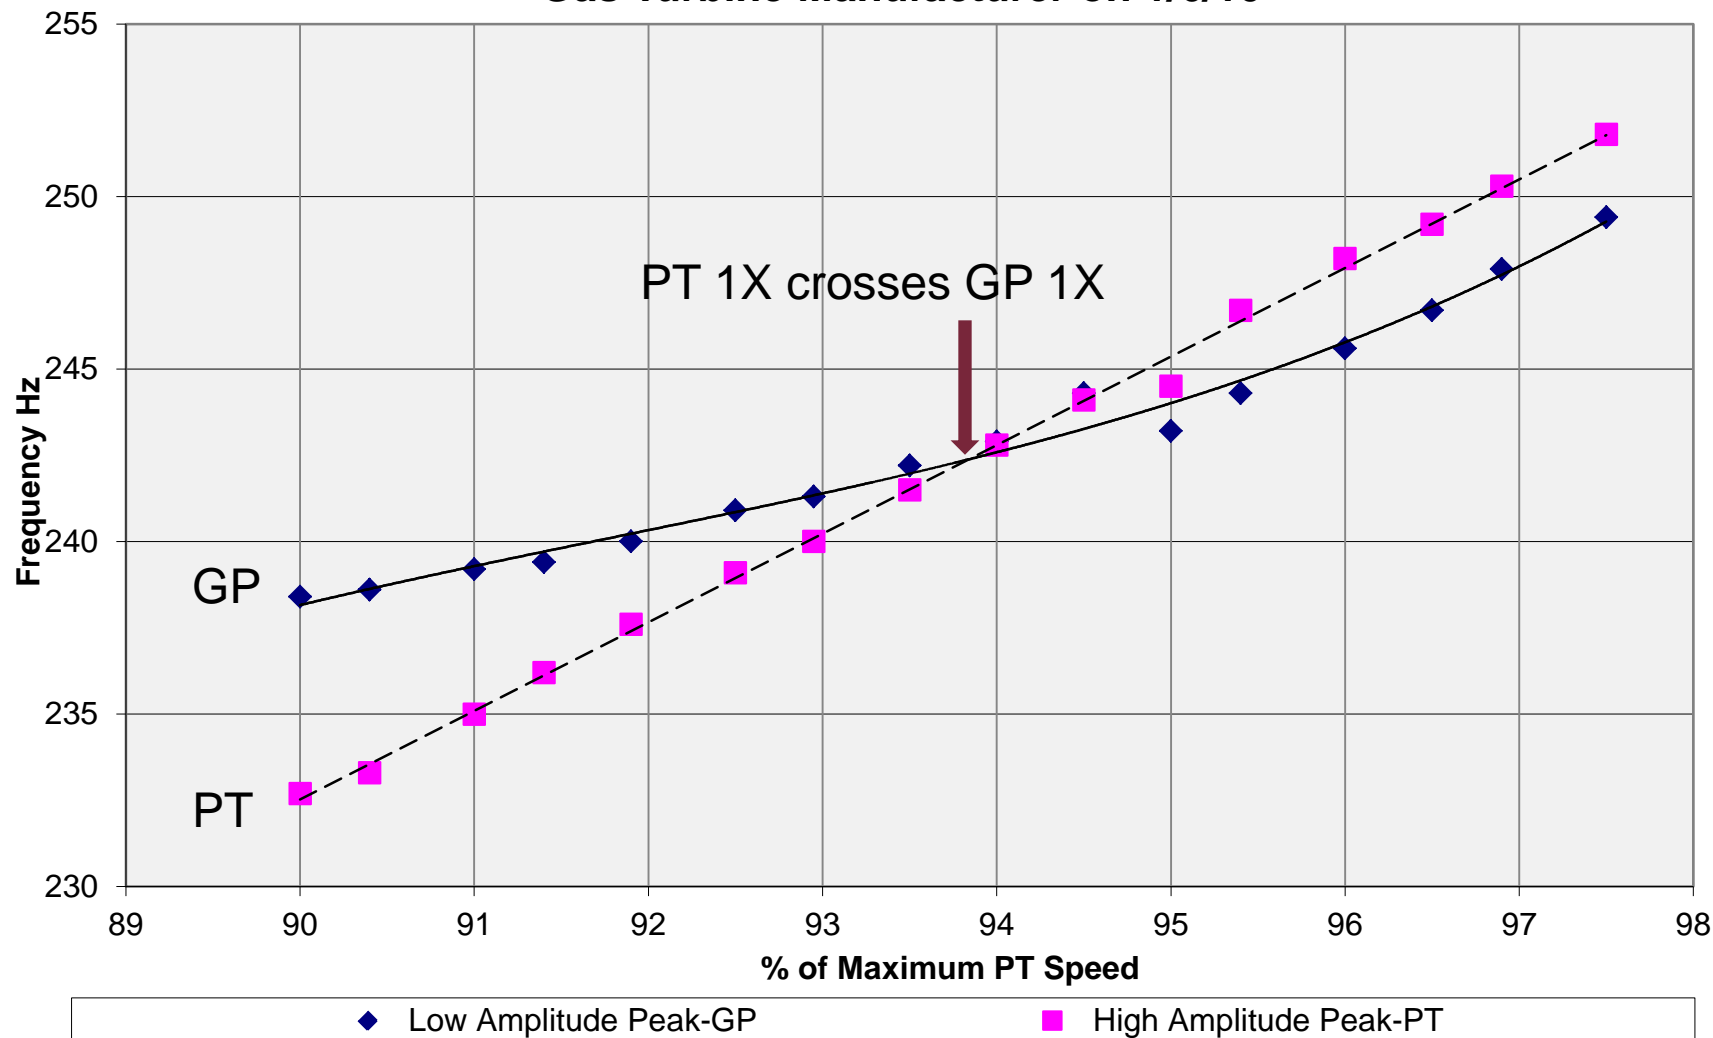
# Zoom Analysis Results from PT Speed Sweep

It was soon discovered that the larger of the two peaks related to the PT 1x frequency and the smaller sideband peak corresponded to the GP 1x frequency.

Zoom Analysis Results Data taken by  
Gas Turbine Manufacturer on 1/6/10

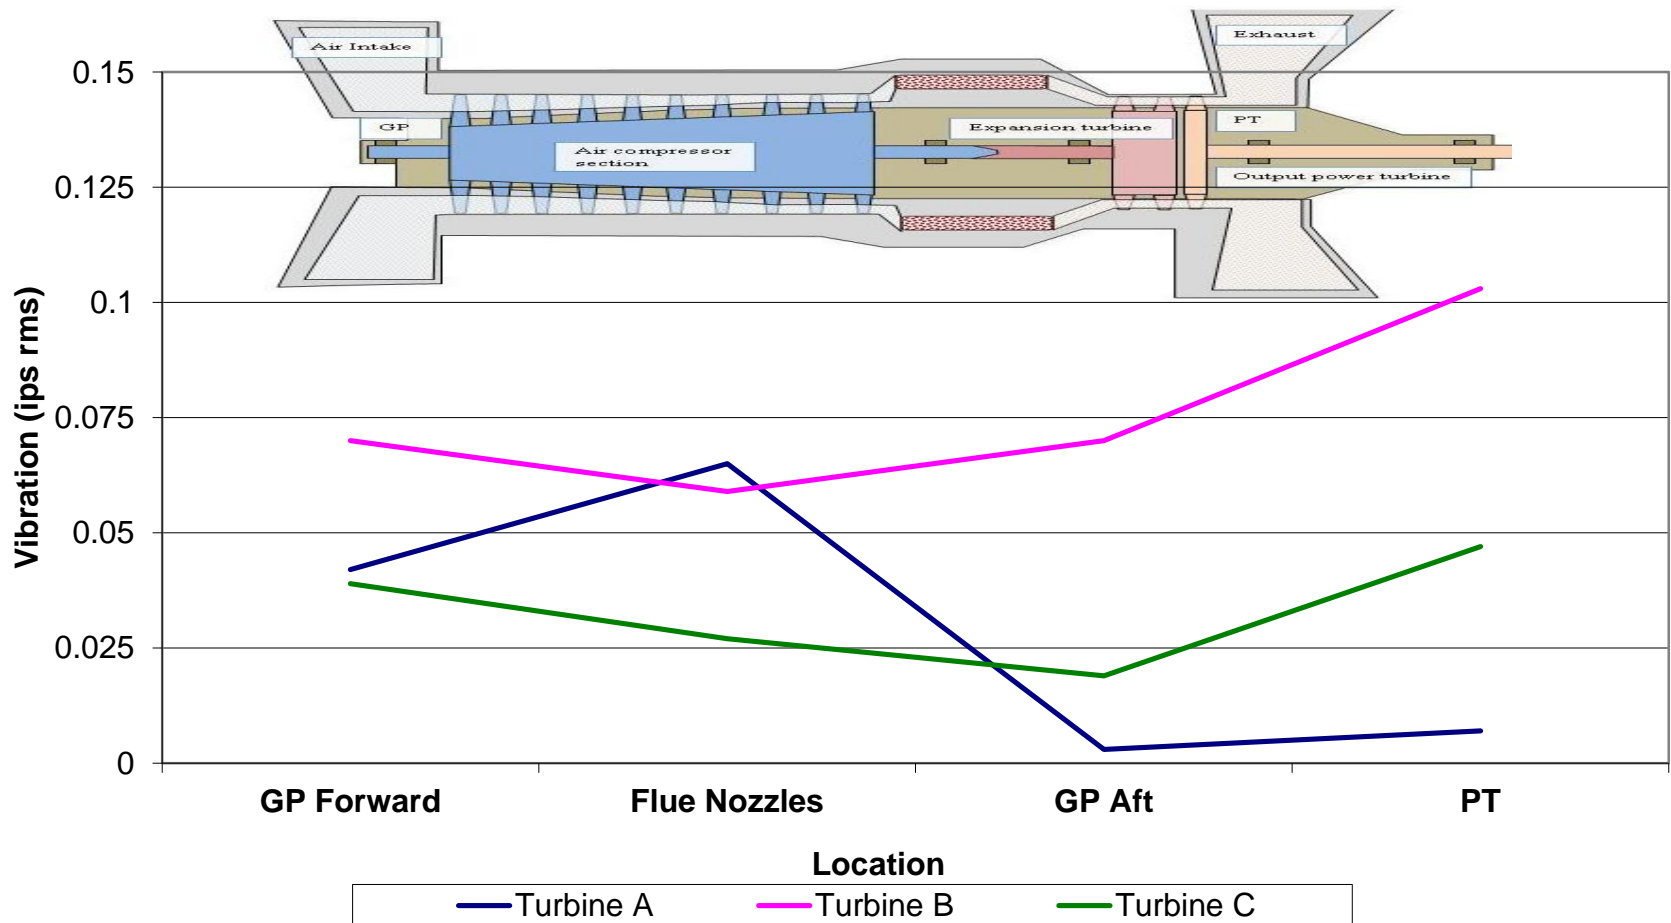
### Gas Producer Vertical Vibration Levels at Different Train Locations

Three (3) similar gas turbines at the site were running at the time of this comparative analysis. Here is a plot showing GP vibration at various locations along the three engines analyzed. Note: Turbine B below is the engine described in the case study. Notice that for some unknown reason it transmits the highest level of GP vibration to the power turbine end.

Turbine B is the gas turbine in the case study
